Supplemental Photo Reconnaissance

A supplemental site reconnaissance was conducted on January 17, 2013 by David Scovel, LPG of BCA. The site visit included observation of the Subject Site and adjoining properties for environmentally significant items, such as gasoline pumps, fill caps, vent lines, unusual cracks or ground discoloration, as well as significant commercial or industrial activity. Photographs were taken of conditions at the time of the site visit. During the site visit the adjoining properties were only observed from public rights-of-way, or other public areas.

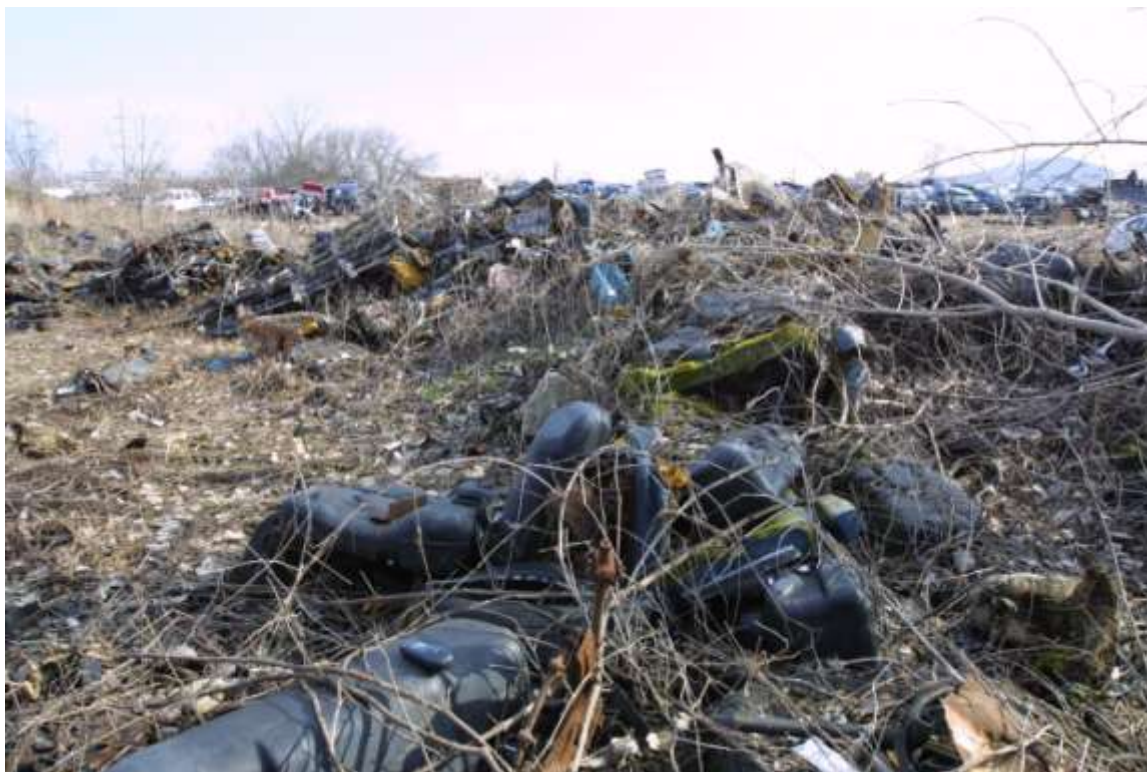
Photo 1: Debris pile "1" scrap poly gas tanks, other scrap. (Looking east). Taken 1/17/2013
UTM: 463774.97 E, 4366539.25 N.

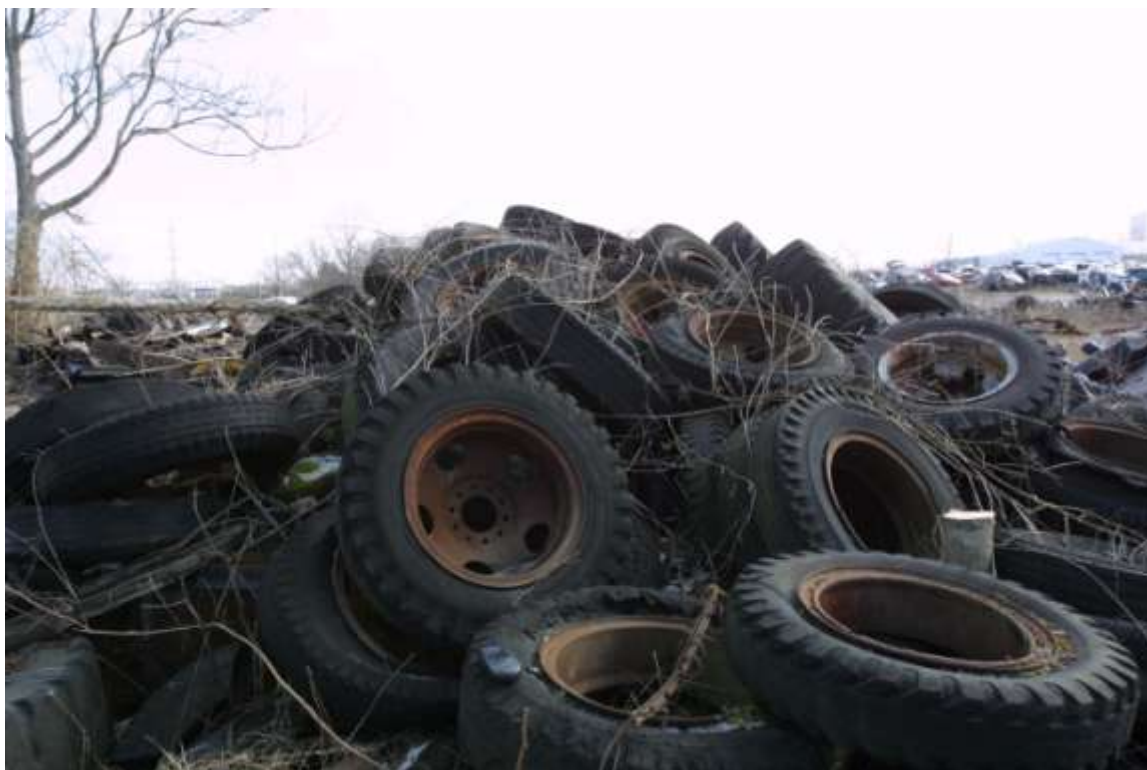
Photo 2: Debris pile "2" tires, rims, some steel scrap. (Looking east). Taken 1/17/2013
UTM: 463771.27 E, 4366563.14 N.

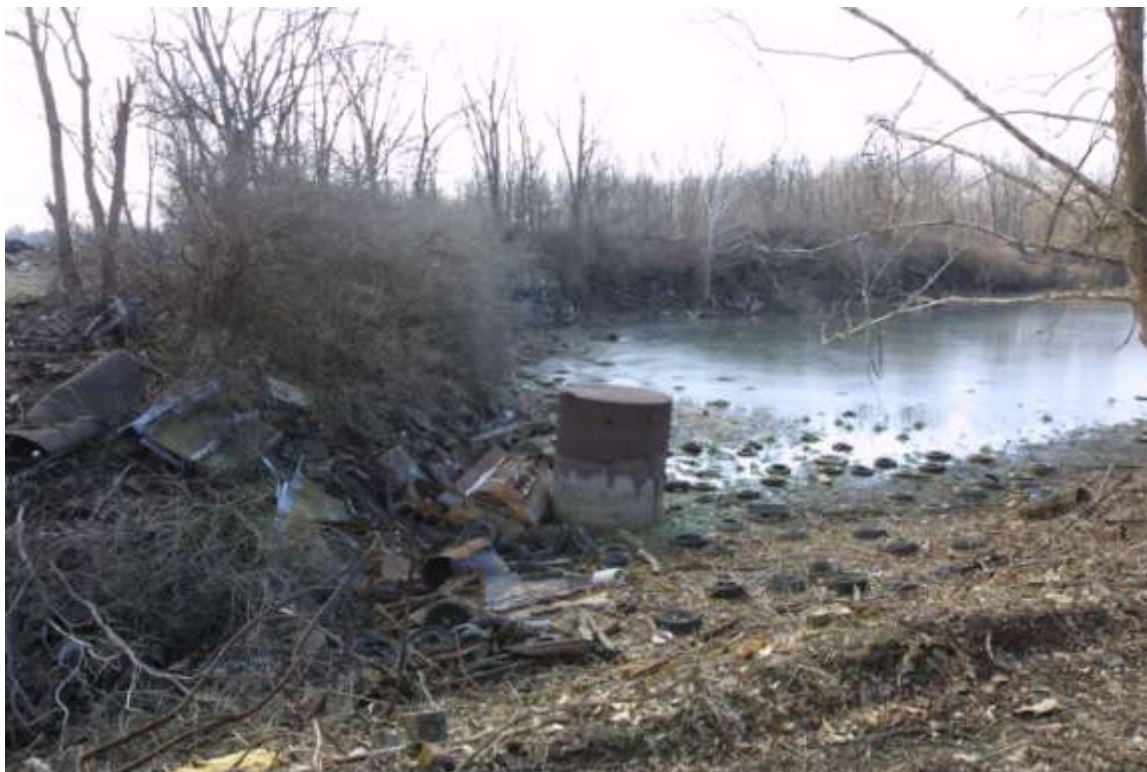
Photo 3: Northeast corner of pond showing tanks and other scrap and debris in and around the pond.
Taken 1/17/2013

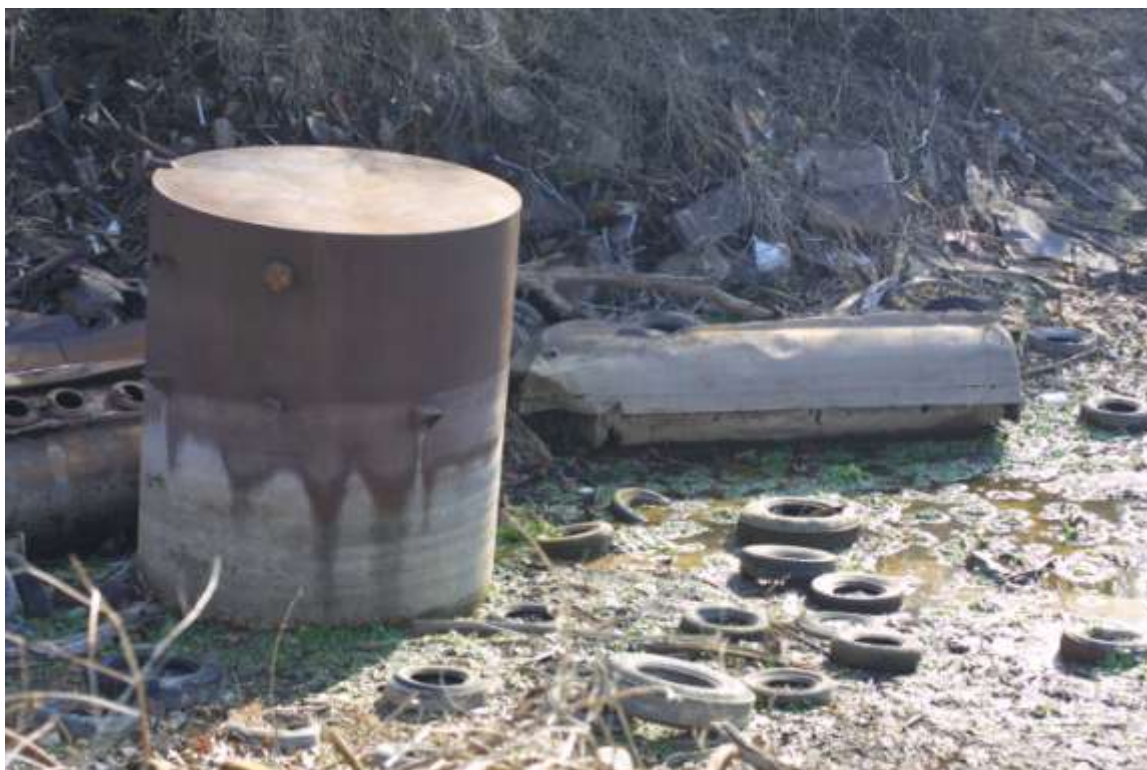
Photo 4: Tanks, tires, and other debris in the northeast corner of the pond - Taken 1/17/2013

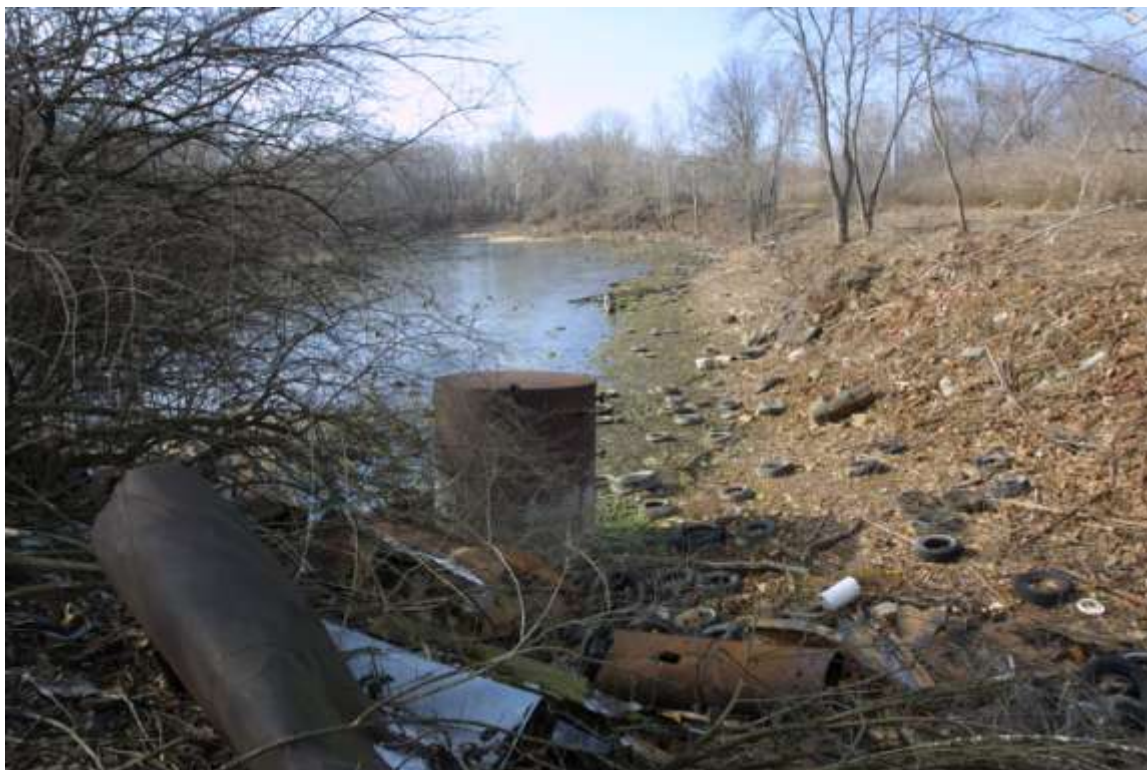
Photo 5: North shore of pond – large tank in foreground left – Photo looking west. Taken 1/17/2013

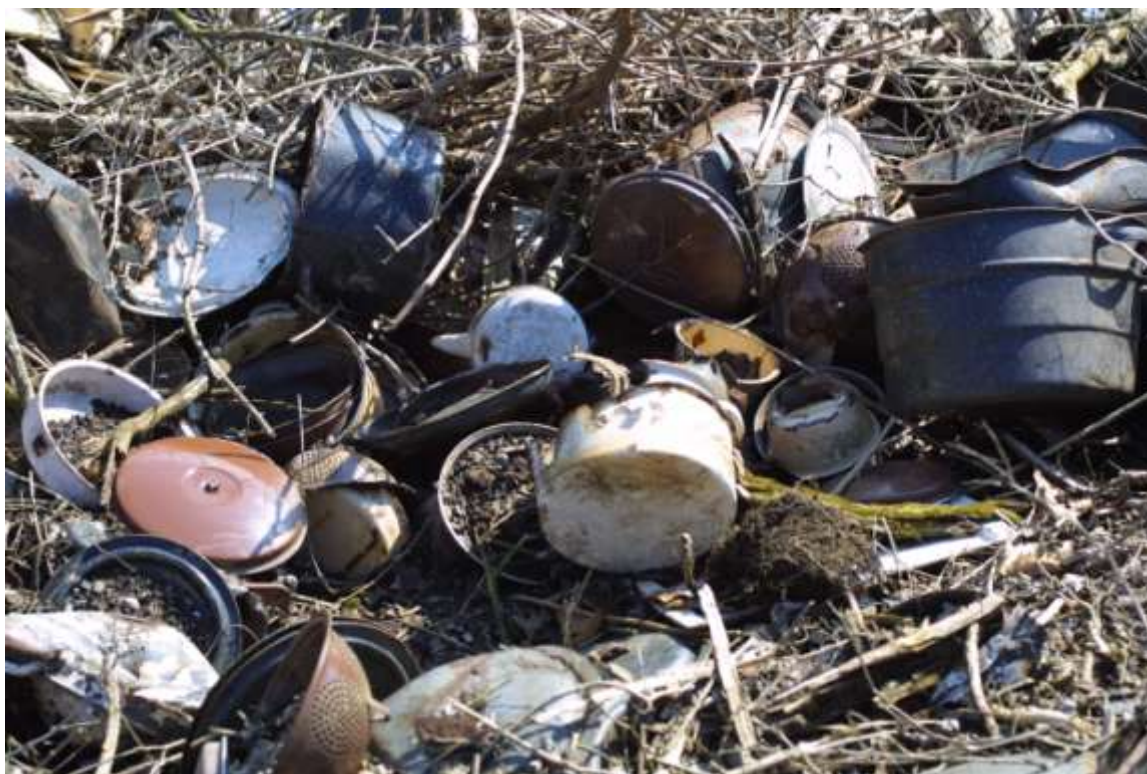
Photo 6: Typical metal scrap and trash along north side of pond (Hulman Street Extension) Taken 1/17/2013

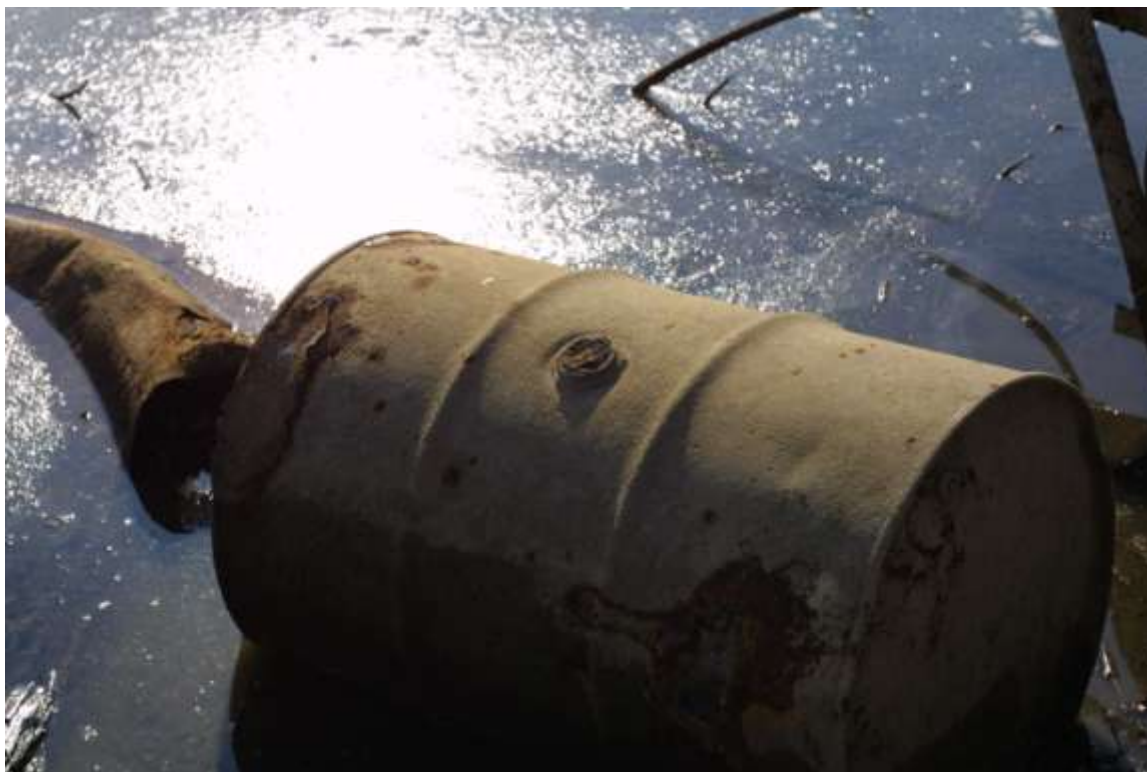
Photo 7: Drum located along north side of pond. A solvent smell was noted in the area of this drum -
Taken 1/17/2013

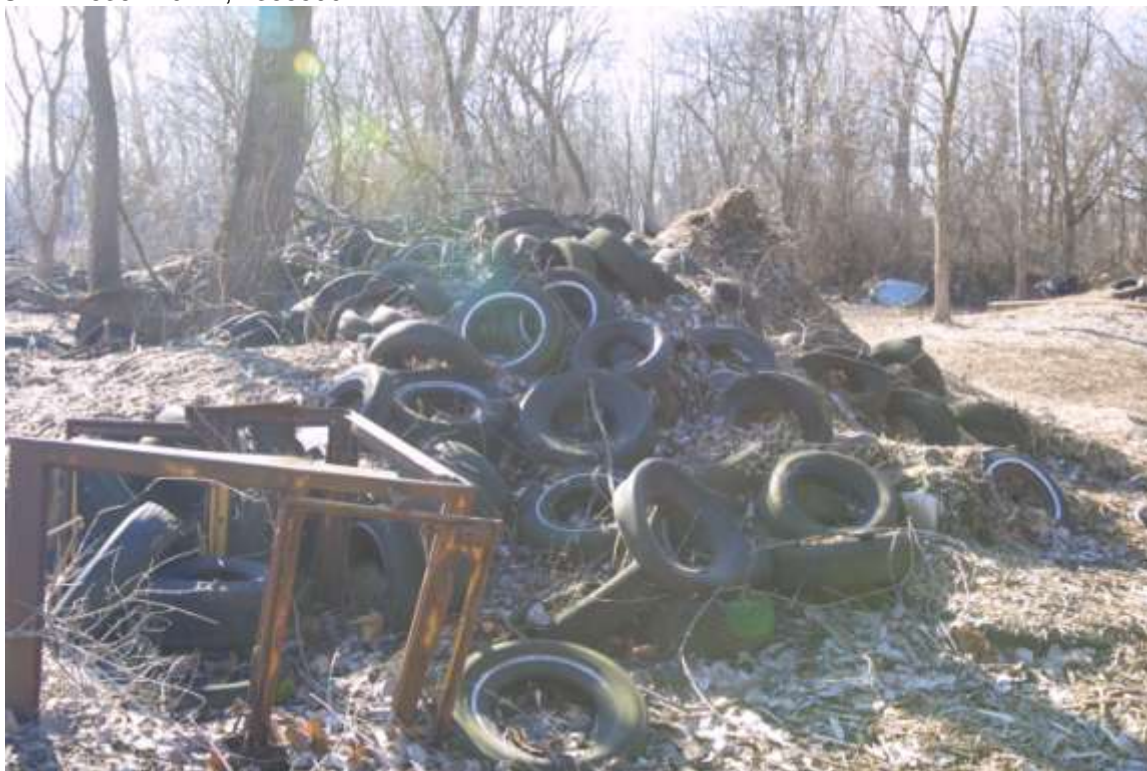
Photo 8: Debris Pile "3" – tires and scrap metal – northwest of the pond, along Hulman Street extension.
Taken 1/17/2013

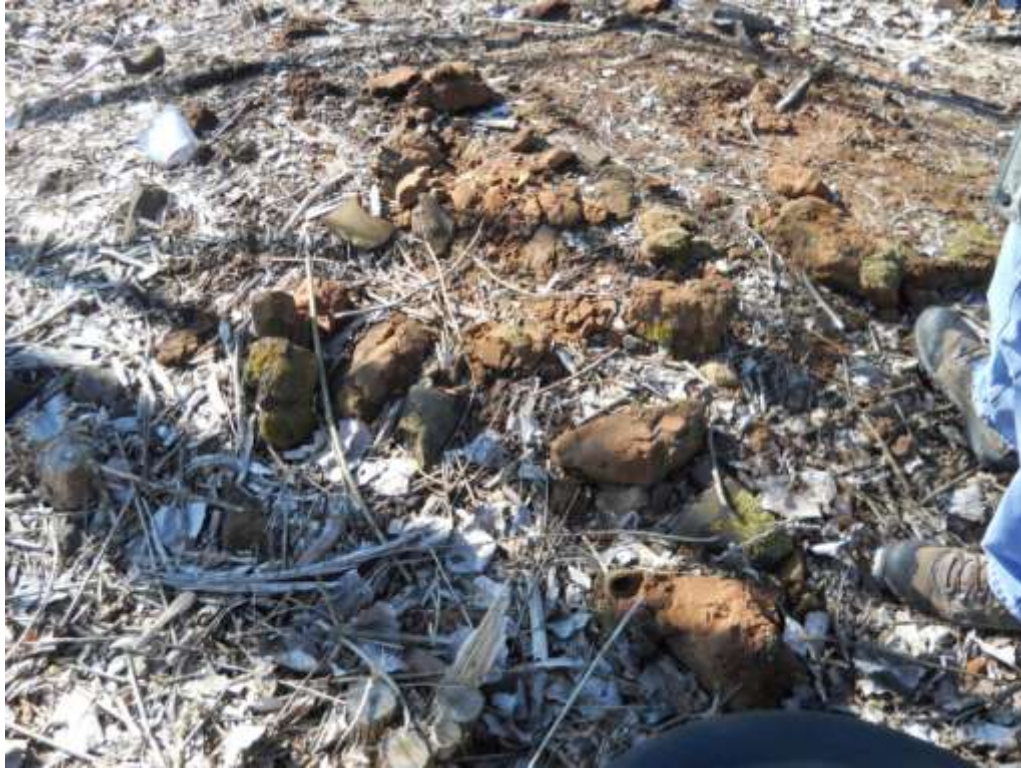
Photo 9: Foundry sand and molds – northwest corner, along Hulman Street extension. Taken 1/17/2013
UTM: 463601.92 E, 4366612.52 N

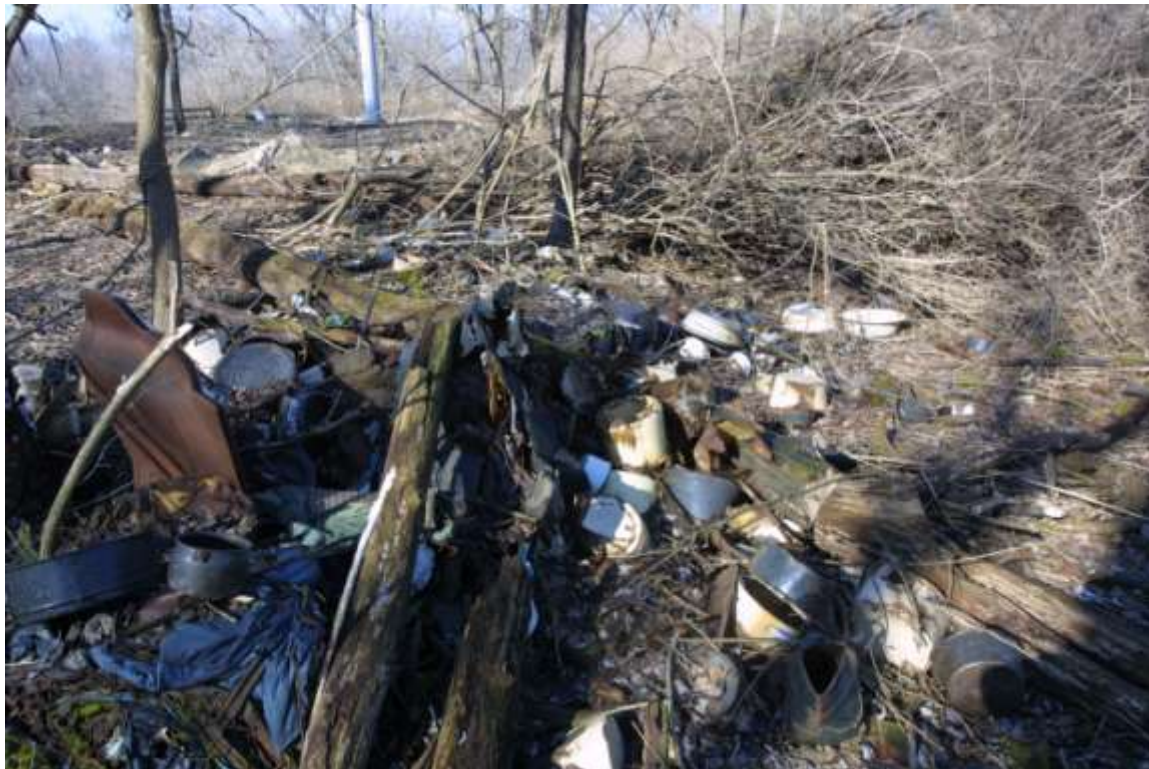
Photo 10: Debris, scrap, and trash pile in wooded area west of pond. Taken 1/17/2013

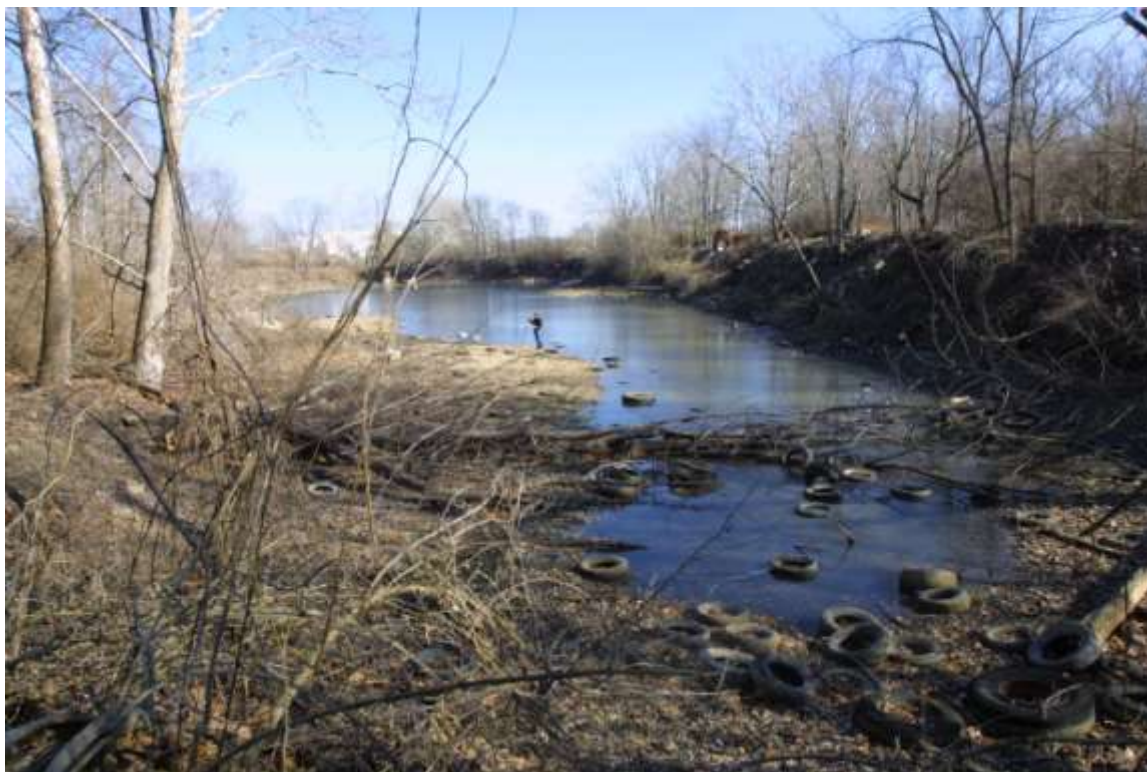
Photo 11: View from southwest corner of the pond, looking east. Taken 1/17/2013

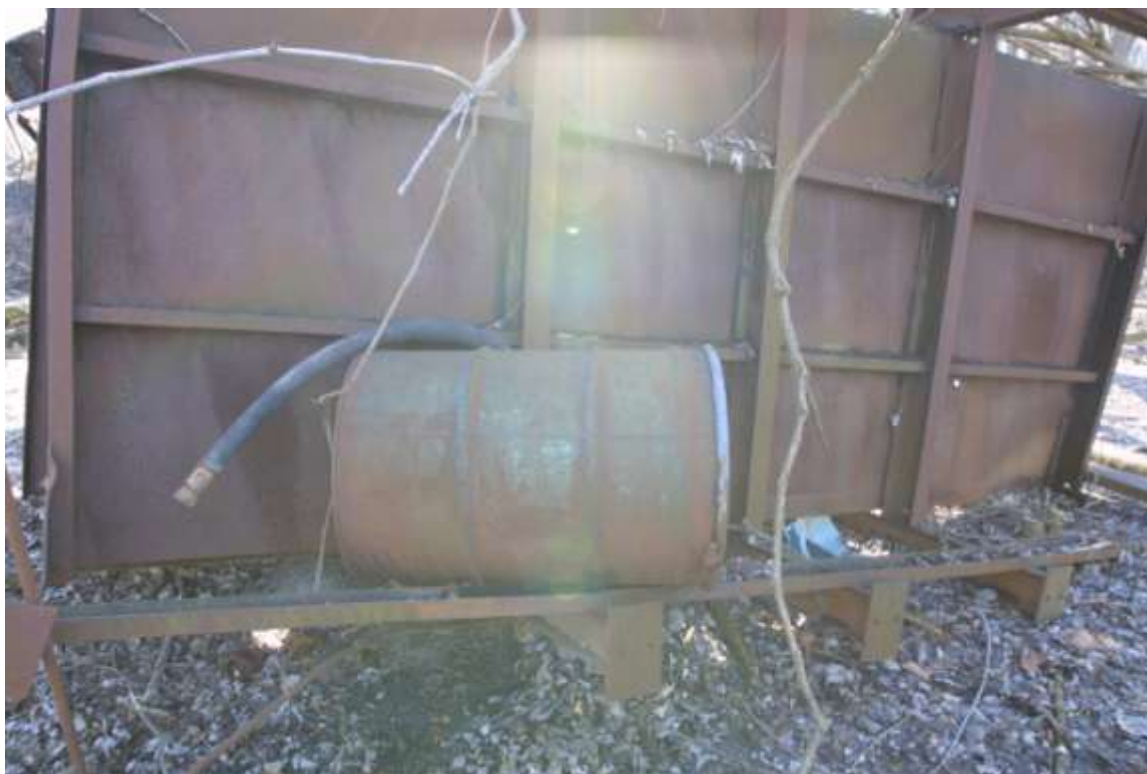
Photo 12: Discarded equipment and drum – wooded area west of pond, north of Idaho St extension (gravel drive) - Taken 1/17/2013

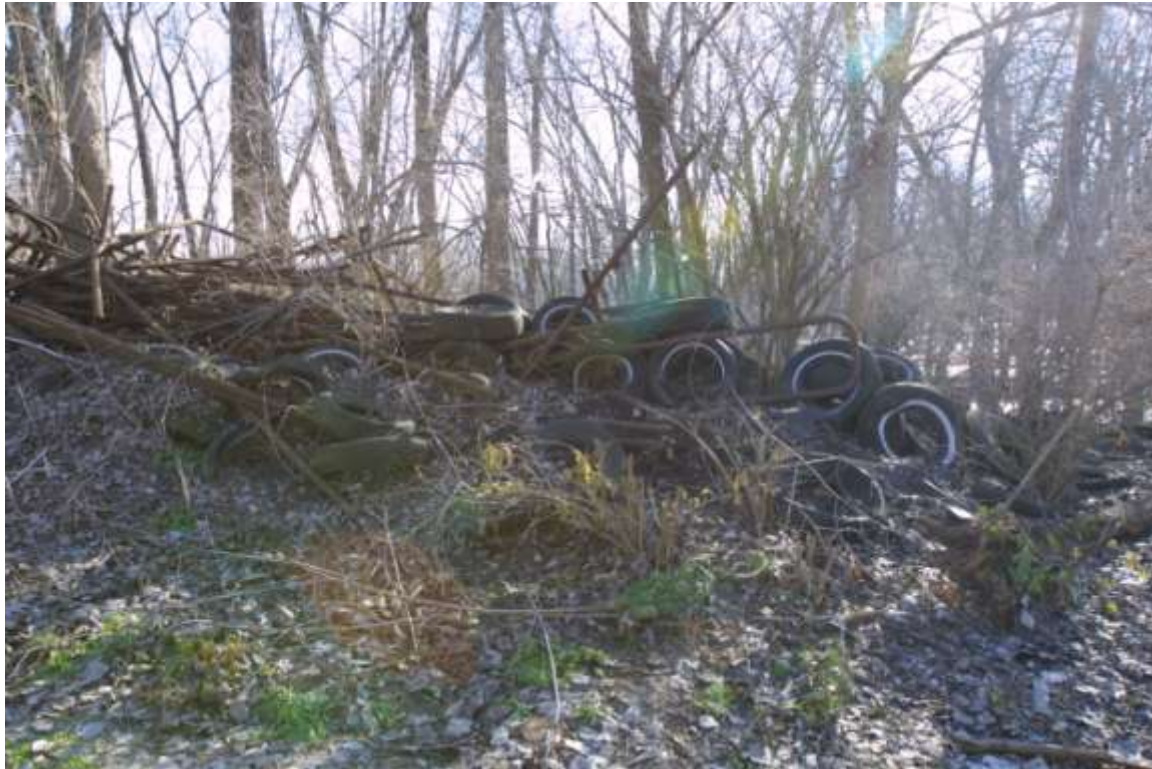
Tires, scrap metal, debris, and fill material containing CA&C was observed on the south side of and at the west end of the Idaho St Extension (Photo 13). Tires and scrap from this pile can be seen down to the flood plain area south of Idaho St. Scrap vehicle parts, debris, metal, trash, a discarded Underground Storage Tank, and several scrap vehicles were observed along the north side of Idaho St – or the south bank of the pond and into the water line (Photos 14, 17 – 18). A number of vehicles and scrap material was observed on the south side of Idaho Street, extending down the embankment into the waters of the flood plain (Photos 15 – 16; 19 – 21). Along the eastern property line, south of Idaho Street, the embankment consists almost entirely of scrap and discarded vehicles and fill material from below the waterline to the top of the back filled area of the scrap yard (Photo 19). The southeast corner of the site (Photo 22) had a raised mound, and was reported to be remediated. No significant scrap or debris or activity was observed in this area.

Photo 13: Scrap Pile "5" – scrap, debris, tires, and fill material that includes coal, ash, and cinders, located on south side of gravel drive (Idaho St extension) - Taken 1/17/2013
UTM: 463450.78 E, 4366521.21 N

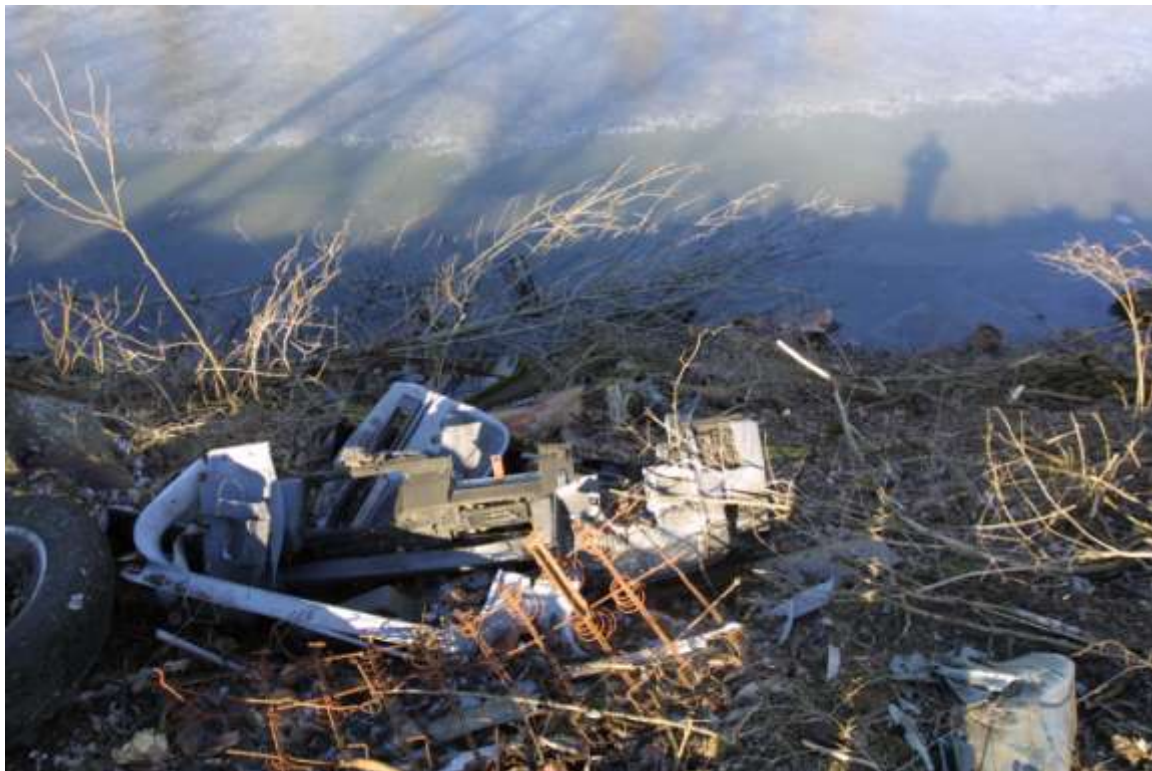
Photo 14: Debris, scrap, and trash along south side of pond, north side of Idaho St extension. Taken 1/17/2013

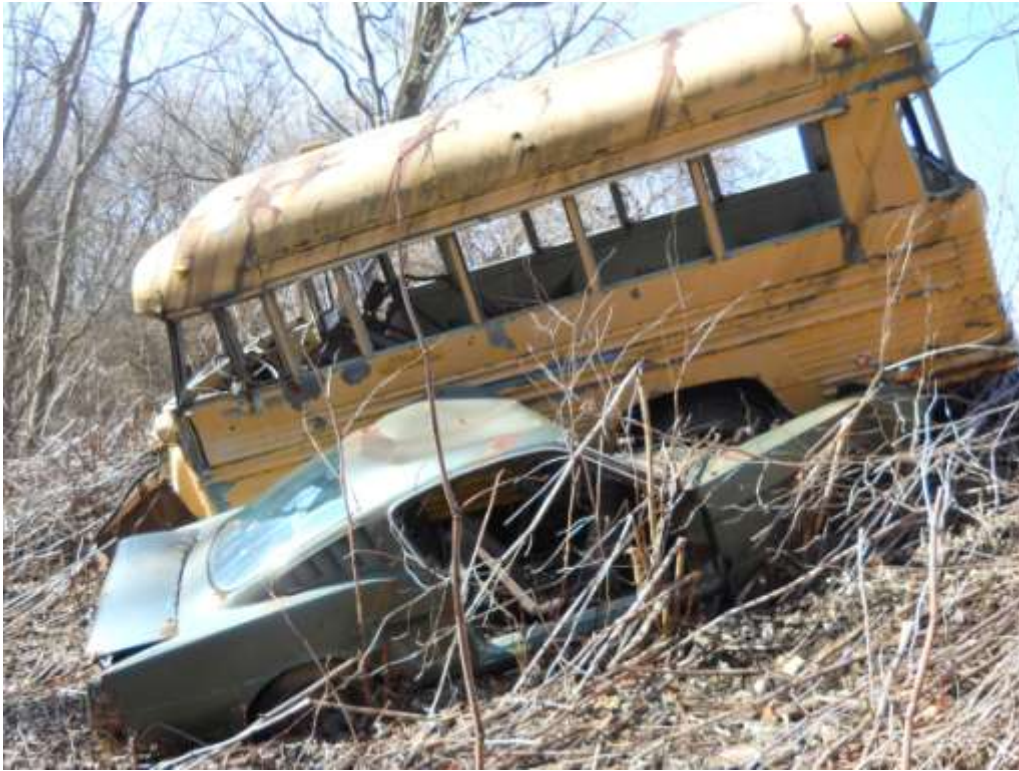
Photo 15: Scrap vehicles along south side of Idaho St extension – steep slope. Taken 1/17/2013
UTM: 463633.16 E, 4366514.02 N

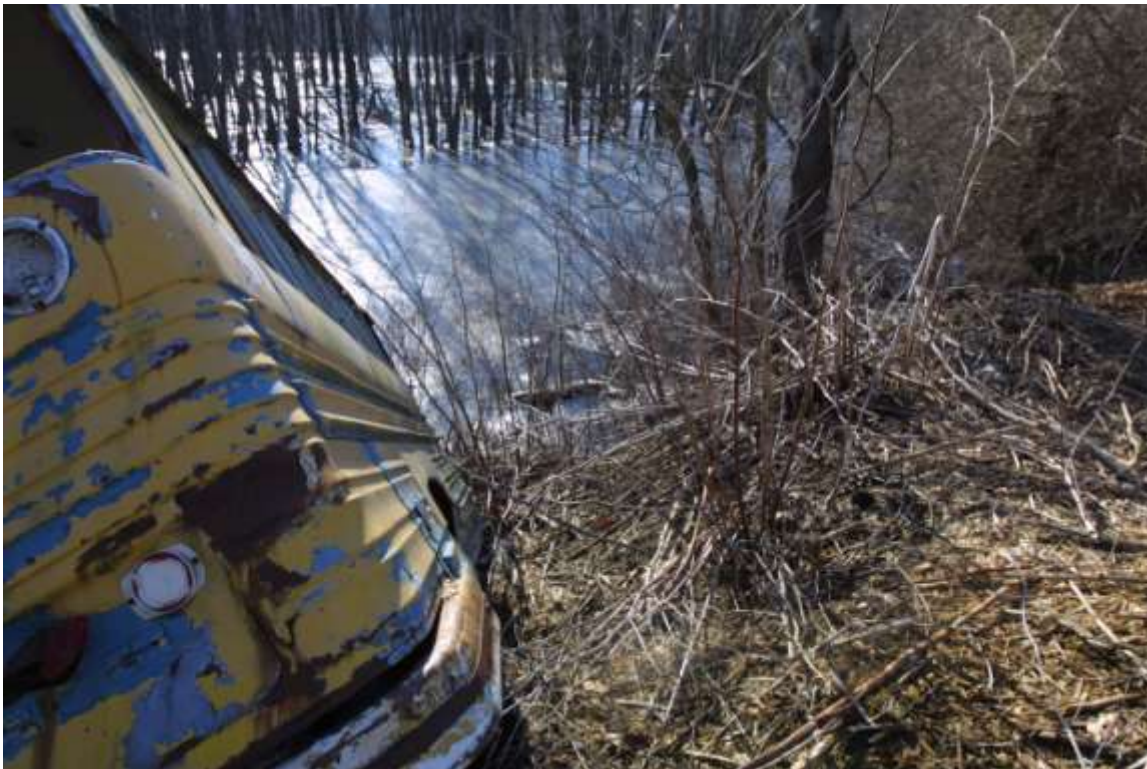
Photo 16: Vehicles in and at water's edge in the flood plain south side of Idaho St extension. Taken 1/17/2013

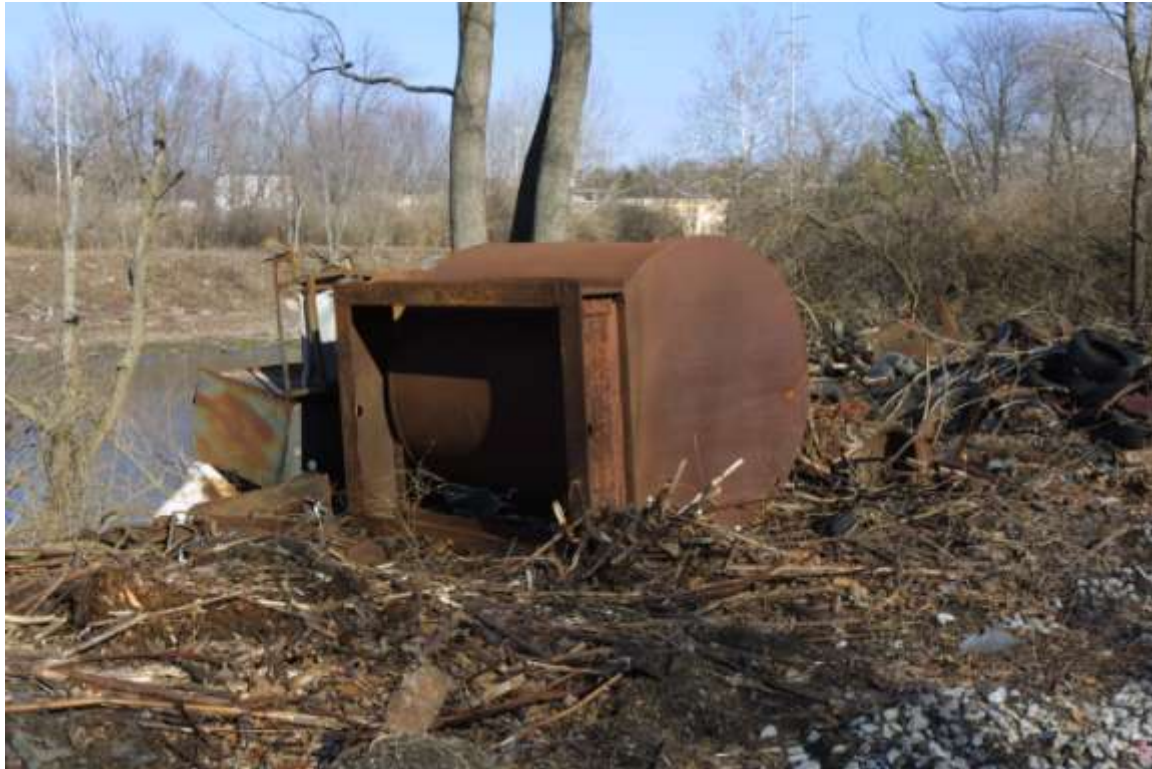
Photo 17: Discarded UST along Idaho St extension, north side of drive. Taken 1/17/2013
UTM: 463653.87 E, 4366531.73 N

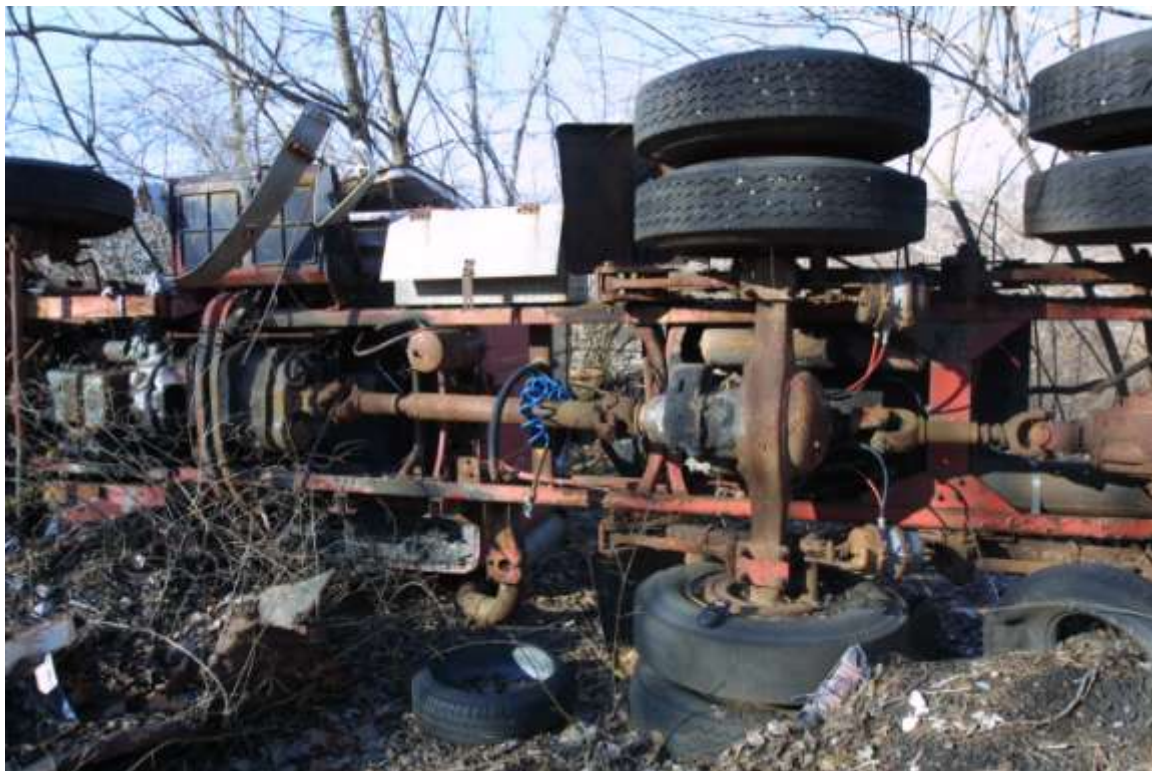
Photo 18: Scrap vehicles along both sides of Idaho Street extension. Taken 1/17/2013
UTM: 463715.51 E, 4366536.46 N

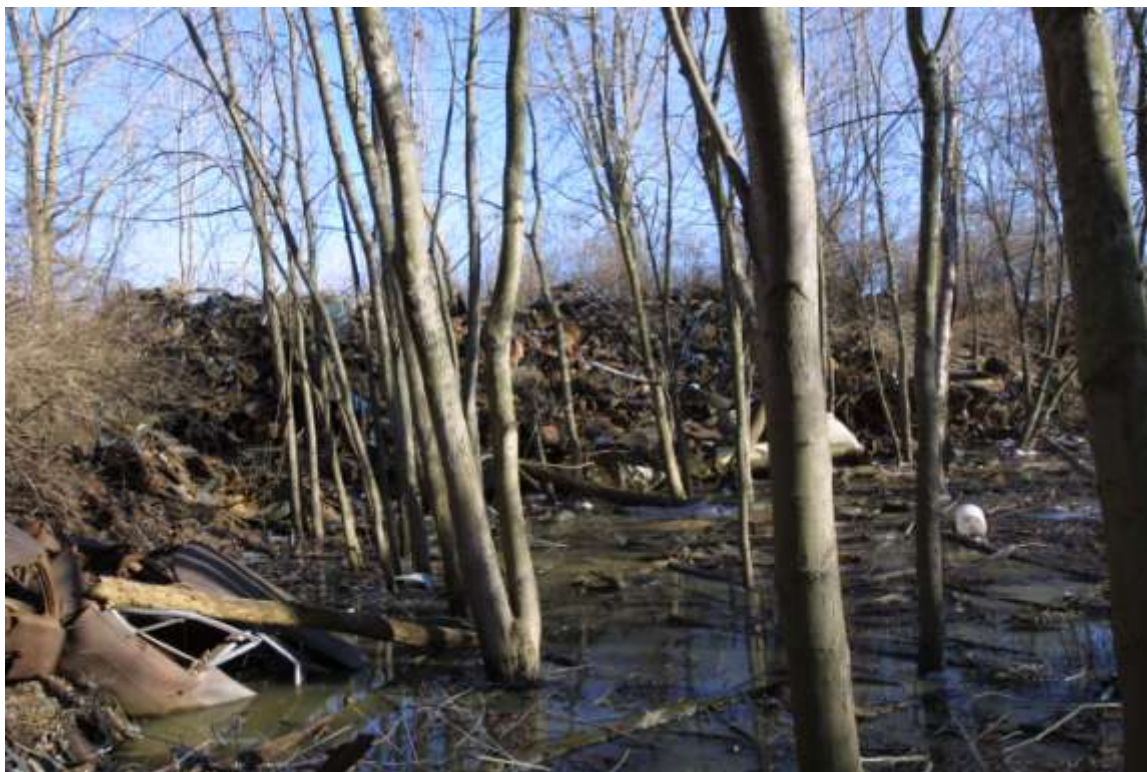
Photo 19 "Wall of scrap" – east property line, south of Idaho St extension, edge of flood plain- photo looking southeast. Taken 1/17/2013

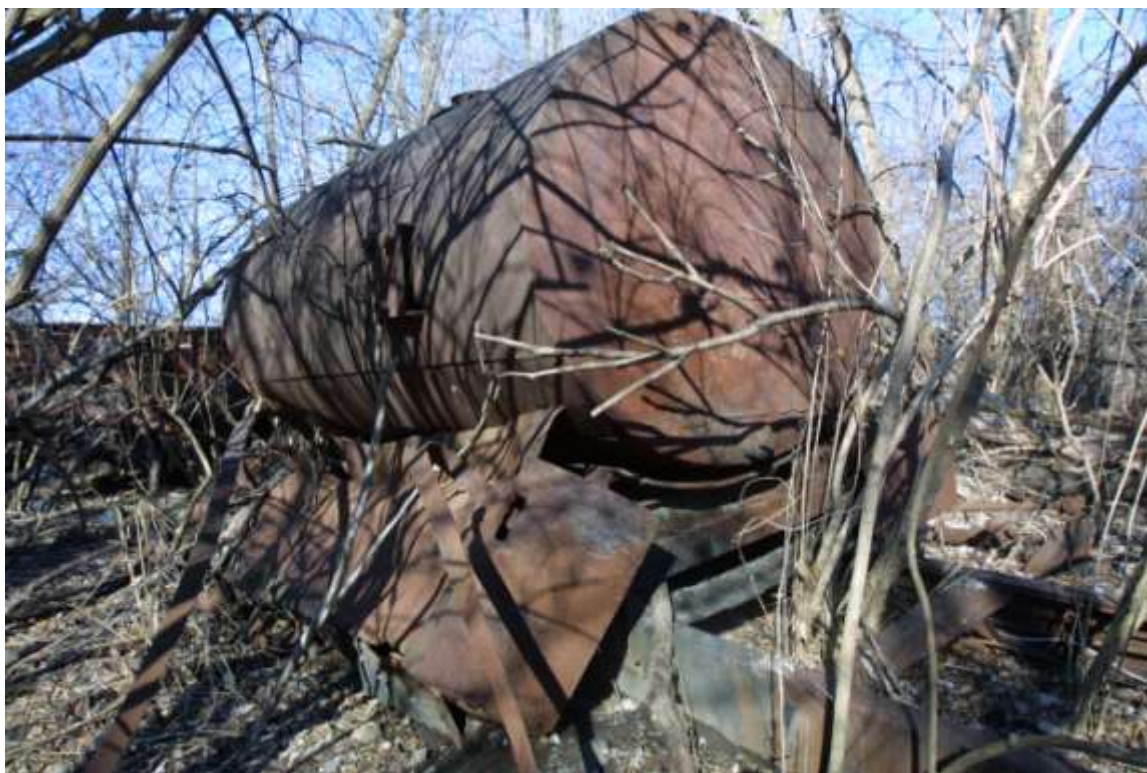
Photo 20: Scrap tanker truck, south side of Idaho St extension. Taken 1/17/2013

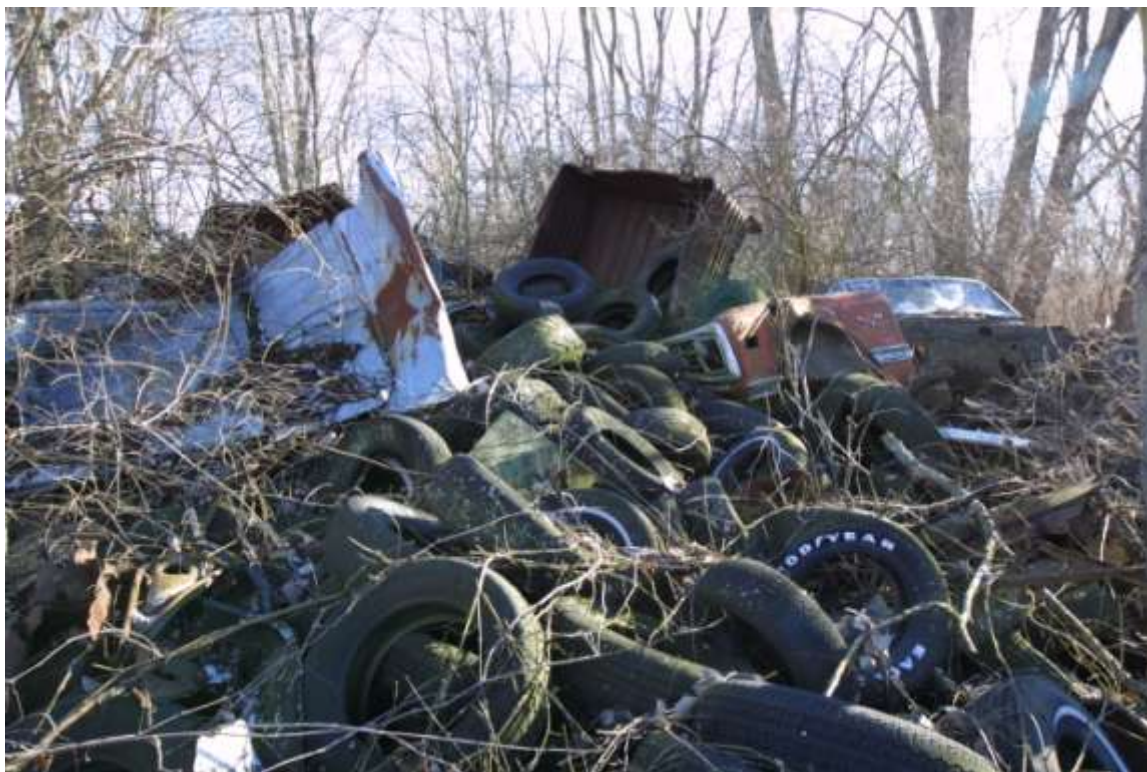
Photo 21: Scrap, debris, and tires, south side of Idaho St extension, near the eastern property line. Taken 1/17/2013

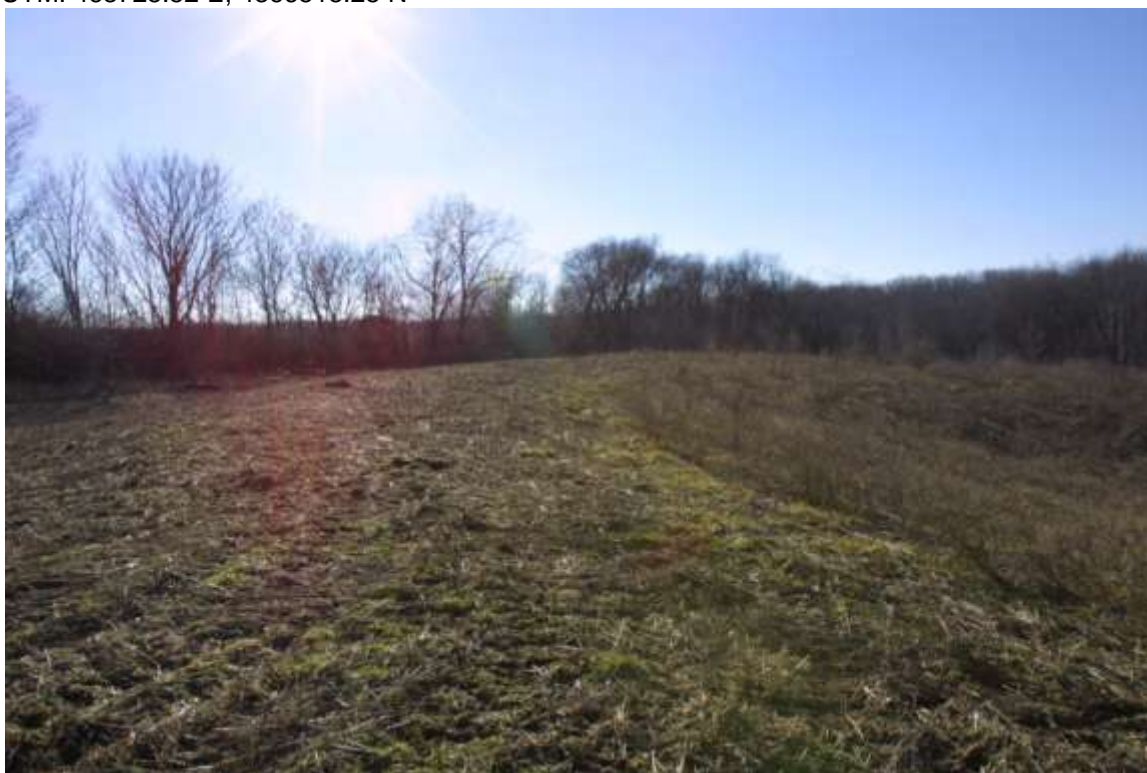
Photo 22: "Remediated area" in the southeast corner of the Subject Site. Taken 1/17/2013
